GRUENDYKE MILL DAM

NJ 00793

PHASE 1 INSPECTION REPORT
NATIONAL DAM SAFETY PROGRAM

REPT. No: DAEN/NAP-53842/NJ00793-81/08 D
AUGUST 1981

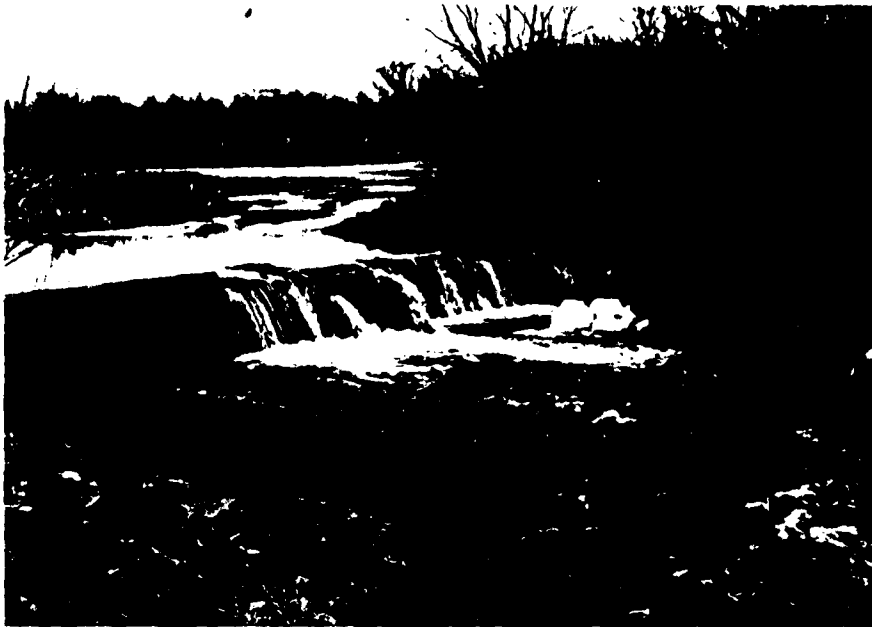
February 19, 1981

The erosion and seepage at the foundation of the former raceway structures could contribute to future stability problems for these structures, if allowed to continue.

Right bank looking u/s at old mill structure foundation

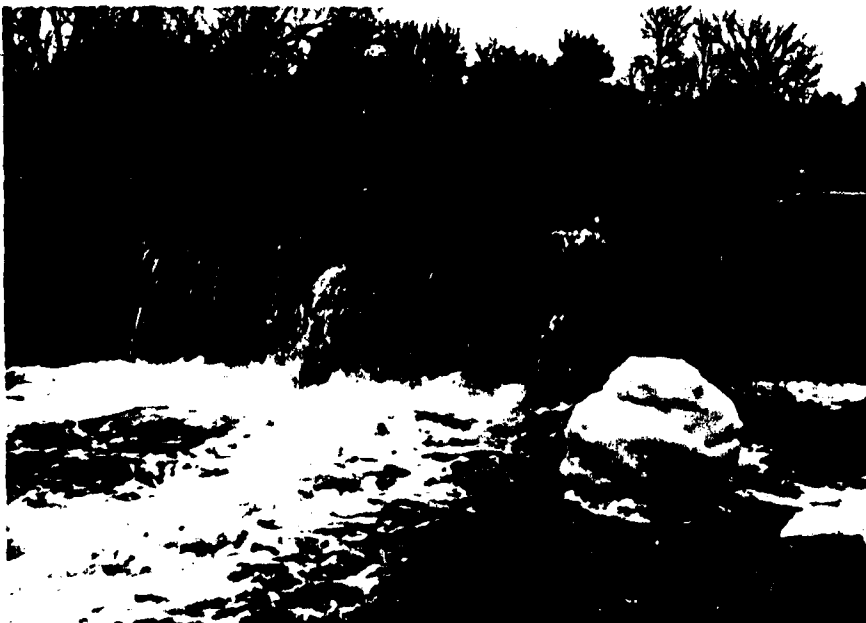
February 19, 1981

Downstream left bank looking at dam u/s toward right side

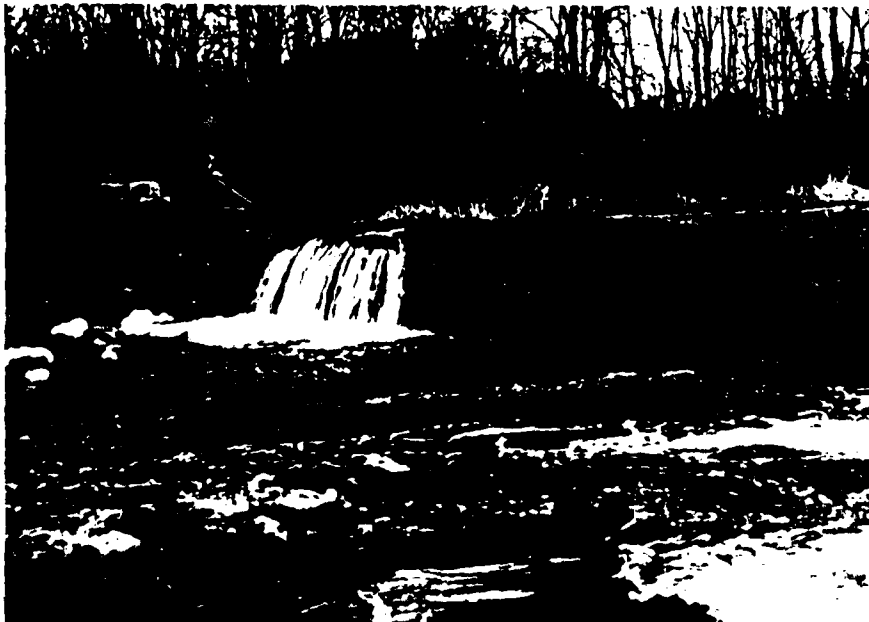
February 19, 1981

View of d/s left bank looking u/s

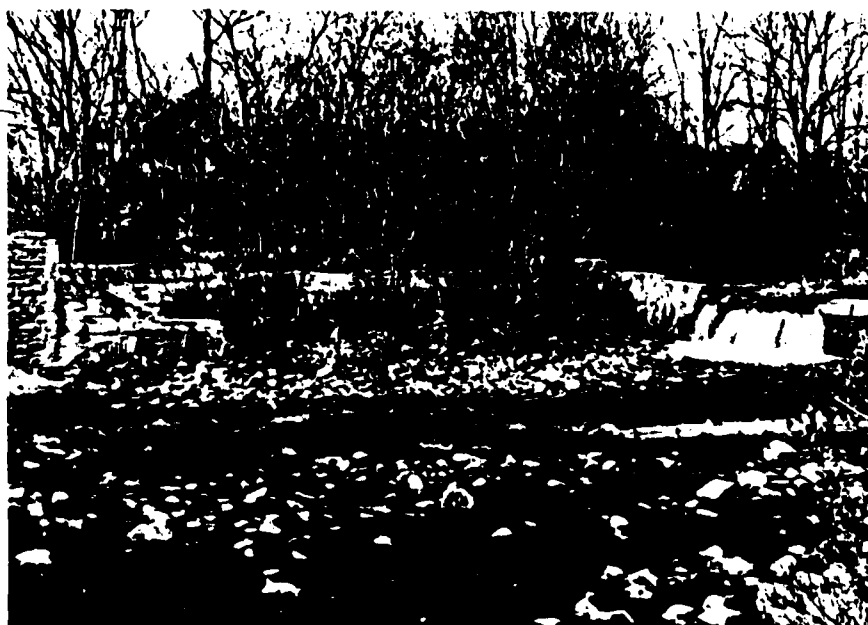
April 21, 1981

View of right side of dam adjacent to waterway structure.

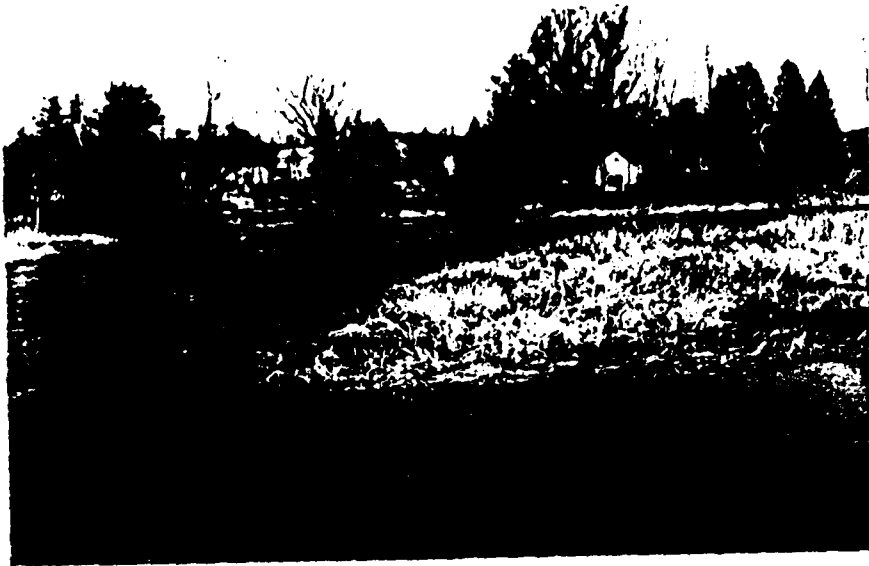
February 19, 1981

c. Reservoir Area. The watershed above the lake is gently sloping, slightly wooded and contains numerous homes. Some open fields exist along the left side of the reservoir. Slopes on the shore appear to be stable. Evidence of significant sedimentation, namely a low lying swampy area just upstream from the dam, was observed. Storage of water behind the dam has been reduced significantly by siltation.

Upstream reservoir area

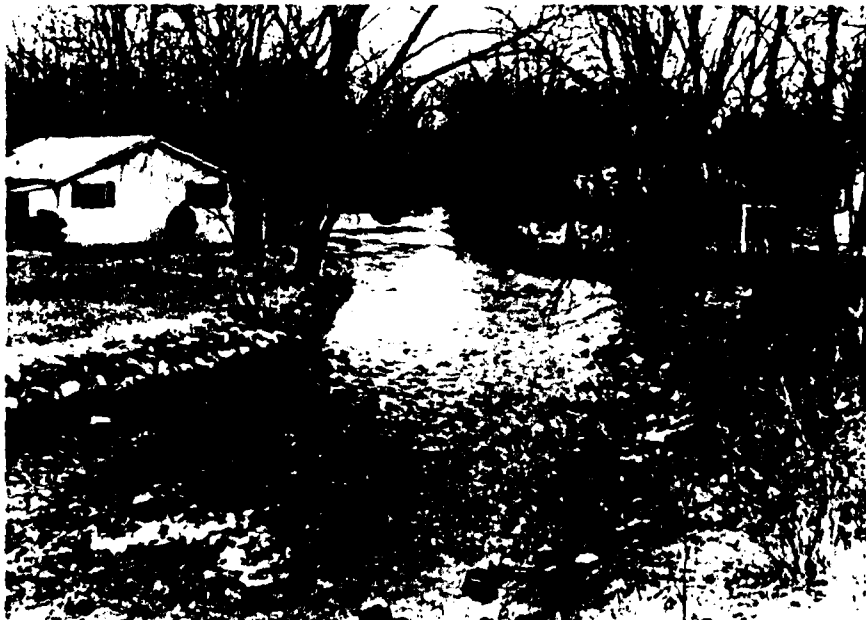
February 19, 1981

Looking d/s from d/s side of Rte 46 bridge at d/s channel
